Assessment of Wood Pile Deterioration due to Marine Organisms

Roberto Lopez-Anido, M.ASCE¹; Antonis P. Michael, S.M.ASCE²; Barry Goodell³; and Thomas C. Sandford, M.ASCE⁴

DOI: 10.1061/(ASCE)0733-950X(2004)130:2(70)

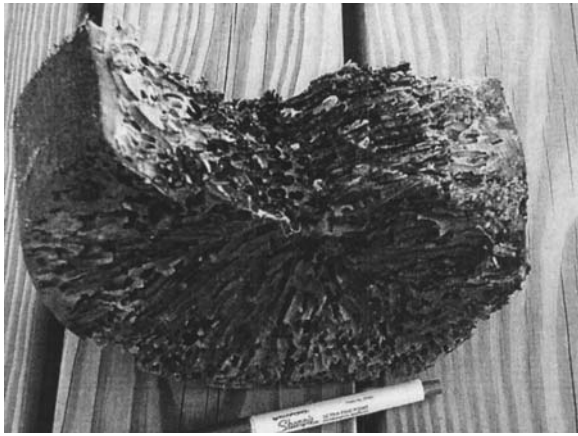
the tunnels become crowded and their length and diameter may be limited. The white shell-like material lining the tunnels can be found mixed with shavings if the wood is bored with a drill during inspection (Highley 1999). Cellulosic portions of the wood are digested with the help of bacterial symbionts. Borer activity will turn the wood into a honeycomb-like matrix, which will lead to a severe reduction in strength even though the outer portion of the pile appears sound (Goodell 2000). A picture of *Teredo navalis* is shown in Fig. 1, where the arrows point to the valves that have been modified for boring through wood (Gillis, personal communication, 2002). *Bankia* spp. is very similar to *Teredo* spp., but is usually larger (Chellis 1961). *Bankia* spp. is shown in Fig. 2. Typical shipworm damaged wood pile sections extracted from Belfast Harbor, Me., are shown in Fig. 3.

Fig. 3. Typical shipworm damage, Belfast, Me.

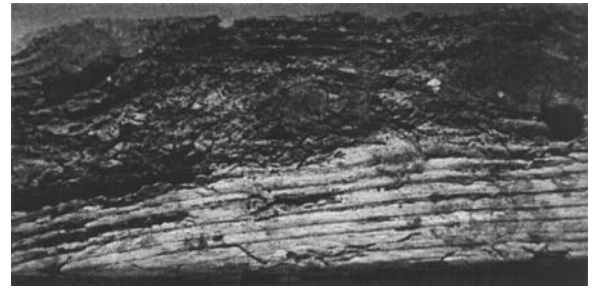
Fig. 4. *Limnoria* spp. damaged wood

tunnel at another location. They commonly attack in coastal regions making shallow burrows in the surface of the wood (Johnson 2002) as shown in Fig. 4. When large numbers of gribbles attack, only a thin layer of wood is left between the burrows. The action of the waves and tidal currents wash away these thin layers exposing new surfaces for the gribbles to attack. This causes extensive thinning of the wood section. In wood piling, the damage caused by gribbles is typically greater in the tidal zone (Chellis 1961).

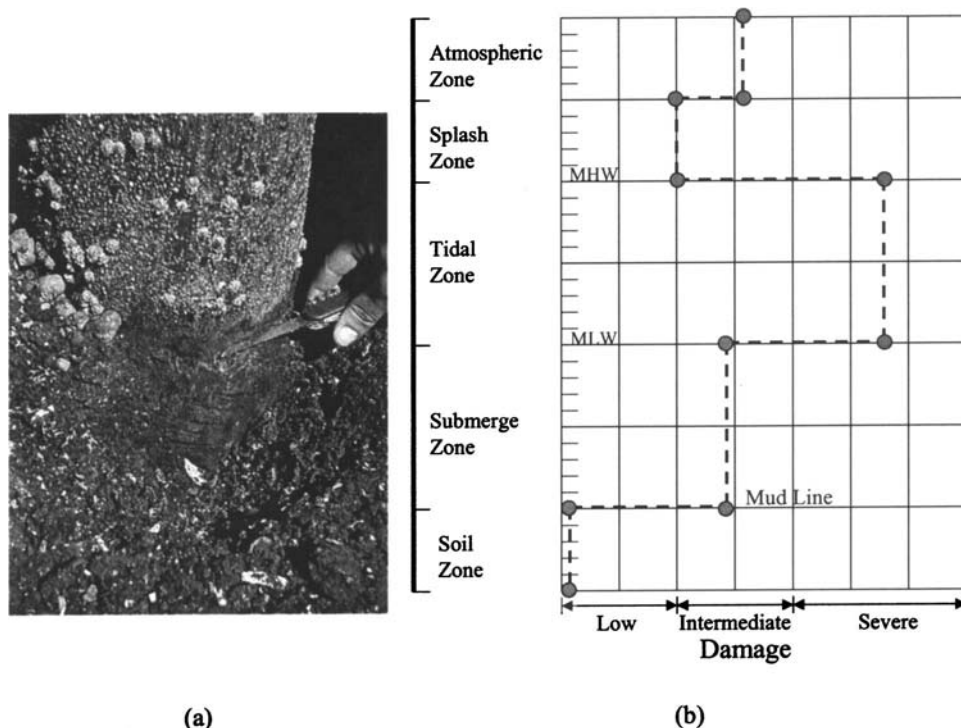
Fig. 5. (a) Wood pile at mudline in Portland Harbor, Me.; (b) typical damage profile of wood pile

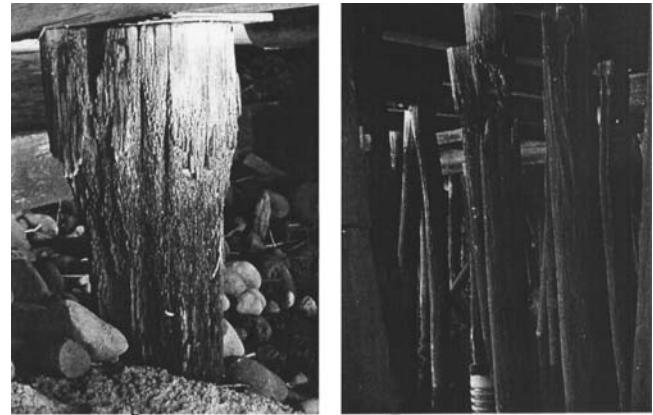
Fig. 9. (a) Typical *Limnoria* spp. damage, Portland, Me.; (b) damaged piles, Portland, Me.

Damage was observed at the Portland pier in several wood piles, as shown in Figs. 9(a and b). In some cases, a loss of cross section (necking in the intertidal zone) up to 70% was observed. It was observed that several old damaged piles were left in place, and new wood piles were driven nearby. In other cases the old damaged piles were cut off, and a new pile portion was spliced on top.
