MIAMI BUILDING FIRST TO BENEFIT FROM INNOVATIVE PILE JACKET

BY MO EHSANI AND ABHI TIPNIS

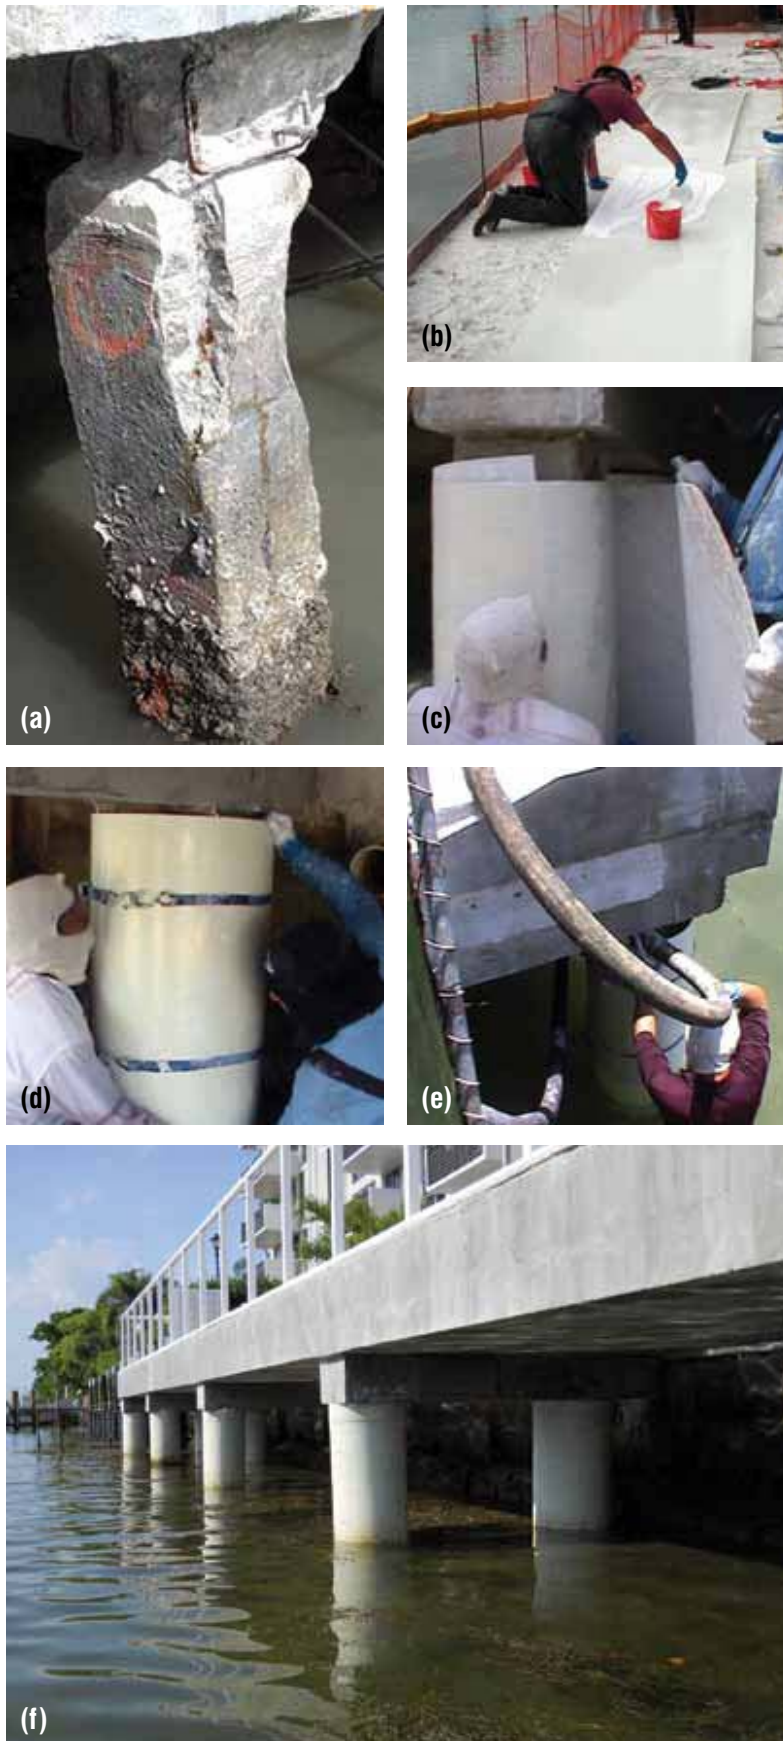
The 14 x 14 in. (356 x 356 mm) piles (refer to Fig. 4(a)) had substantial steel corrosion and spalled concrete. While searching for a repair methodology, the contractor recommended using the new FRP laminates for the piles that supported an overlook on the pool deck, for ease of installation and the added structural enhancement.

was mixed using a jiffy mixer and applied with a thickness of 40 mil (0.04 in. [1 mm]) to the $66 + 8 = 74$ in. (1880 mm) length of the laminate; the first 66 in. (1680 mm) length of the laminate that will be placed next to the pile does not need to be coated with epoxy (refer to Fig. 4(b)).

Because the water was relatively shallow, the workers could pick up the laminate and walk it in water. At this time, the laminate is wrapped around the pile to create the 21 in. (533 mm) diameter shell (refer to Fig. 4(c)). At this stage, the uncured epoxy coating serves as a lubricant, allowing the laminate to slide easily as the crew makes final adjustments to the diameter of the shell. Ratchet straps were used to fix the diameter of the shell and prevent it from unraveling before the epoxy cures (refer to Fig. 4(d)). The cylindrical shell can be moved vertically along the height of the pile to its final position. In this case, it was pushed down into the mud to create a seal at the base.

An underwater grout was mixed and pumped with a hose into the annular space between the jacket and the pile (refer to Fig. 4(e)). As the tremie mixture rose to the top, it displaced the water in the annular space until the entire annular space was filled with grout. At this stage, the hydrostatic pressure of the grout pushes the two layers of the FRP jacket tightly against one another while the ratchet straps prevent the jacket from opening up. At the same time, the heat generated from the hydration process of the grout helps with the curing of the epoxy. Depending on the ambient temperature, the epoxy will cure in several hours, at which time the ratchet straps can be removed. The repaired piles at the conclusion of the project are shown in Fig. 4(f).
