Restoration of Corrosion-Damaged Columns Using PileMedic™

A Patent-Pending Technology Developed by QuakeWrap, Inc.

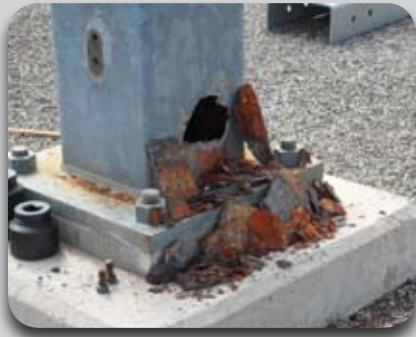
Corrosion-damaged column
