Assessment of Wood Pile Deterioration due to Marine Organisms

Roberto Lopez-Anido, M.ASCE¹; Antonis P. Michael, S.M.ASCE²; Barry Goodell³; and Thomas C. Sandford, M.ASCE⁴

DOI: 10.1061/(ASCE)0733-950X(2004)130:2(70)

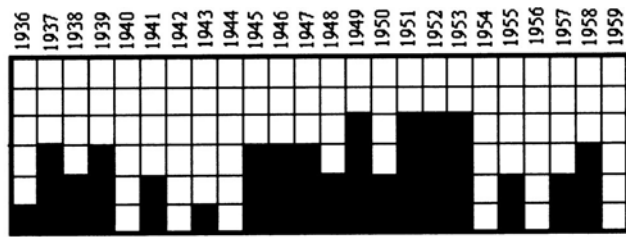
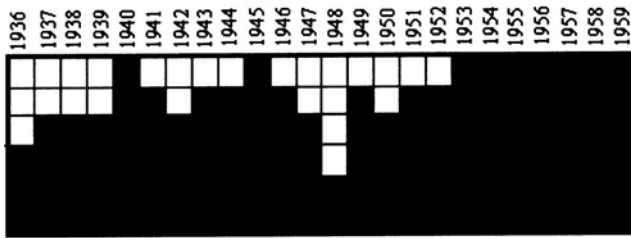
Fig. 8. Typical wood test board results adapted from Wallour (1959): (a) *Teredo* spp., Searsport, Me.; and (b) *Limnoria* spp., Portland, Me.

tional extent of marine borer damage; (2) recent changes in the amount of marine borer attack; and (3) type of marine borer organism. The survey results revealed problems with shipworm damage in wood piles at the same geographic locations in Maine coastal waters reported 41 years earlier (Wallour 1959).
