MIAMI BUILDING FIRST TO BENEFIT FROM INNOVATIVE PILE JACKET

BY MO EHSANI AND ABHI TIPNIS

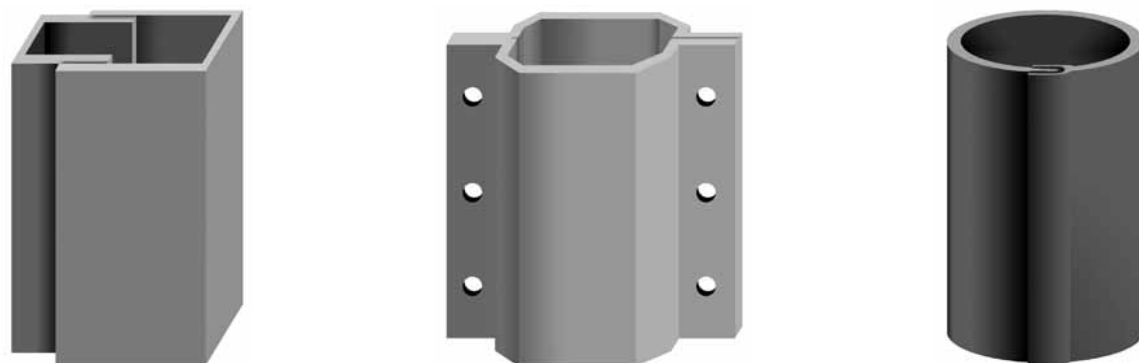
Fig. 1: Typical GFRP jackets used for repair of piles in North America

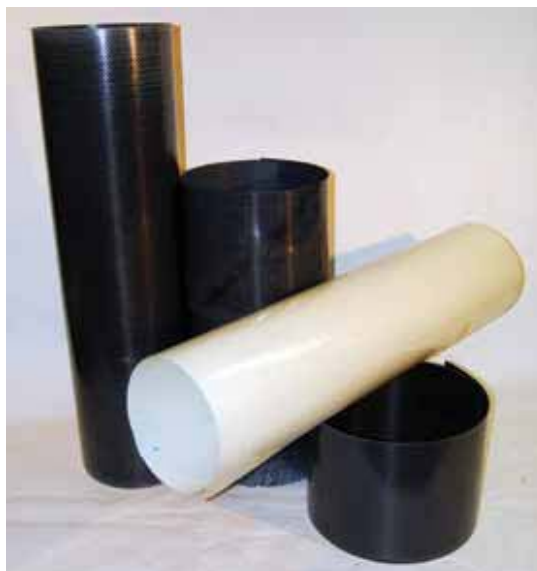
Fig. 2: Sample rolls of FRP laminates

The laminates were packaged in 4 ft (1.2 m) wide x 300 ft (91.4 m) long rolls. The manufacturer's specification requires a minimum double-layer wrap plus an 8 in. (203 mm) overlap beyond the starting point. This reduces the inter-laminar shear stresses between the two plies of FRP and ensures that the pile is confined by two plies of laminates all

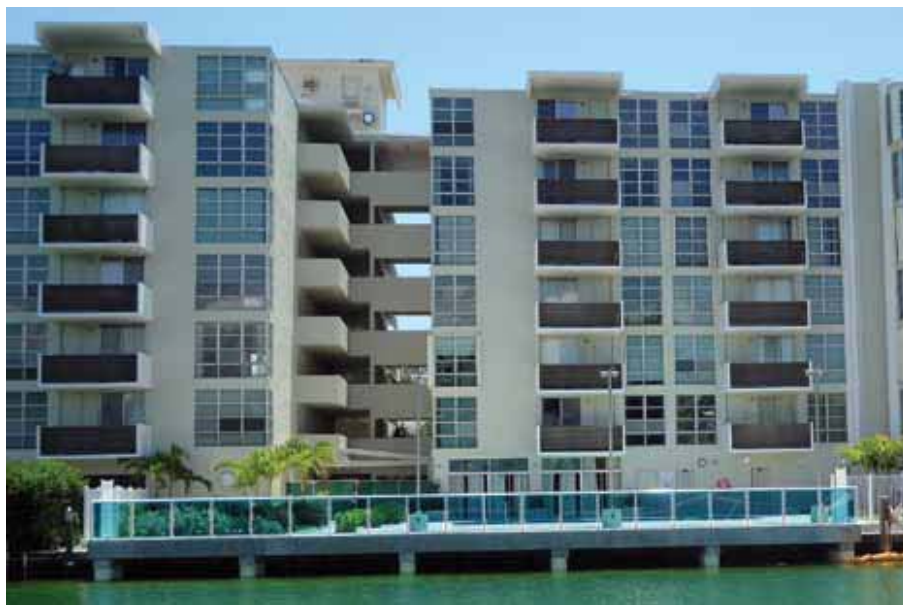
The first application of FRP laminates for the repair of underwater piles was recently completed at Guilford House Condominiums, Bay Harbor Islands, FL (refer to Fig. 3). The project is located on the environmentally sensitive South Florida intra-coastal waterway. Approval from the Florida Department of Environmental Protection (DEP) was required prior to restoration.

Fig. 3: Guilford House Condominiums, Bay Harbor Islands, FL

The 14 x 14 in. (356 x 356 mm) piles (refer to Fig. 4(a)) had substantial steel corrosion and spalled concrete. While searching for a repair methodology, the contractor recommended using the new FRP laminates for the piles that supported an overlook on the pool deck, for ease of installation and the added structural enhancement.
