Experimental Evaluation of Repair Options for Timber Piles

Jawad H. Gull, Alireza Mohammadi, Ramin Taghinezhad, and Atorod Azizinamini

Transportation Research Record: Journal of the Transportation Research Board, No. 2481, Transportation Research Board, Washington, D.C., 2015, pp. 124–131. DOI: 10.3141/2481-16

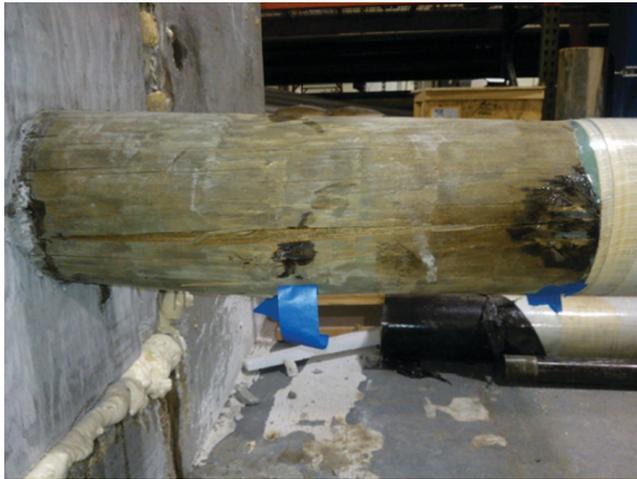
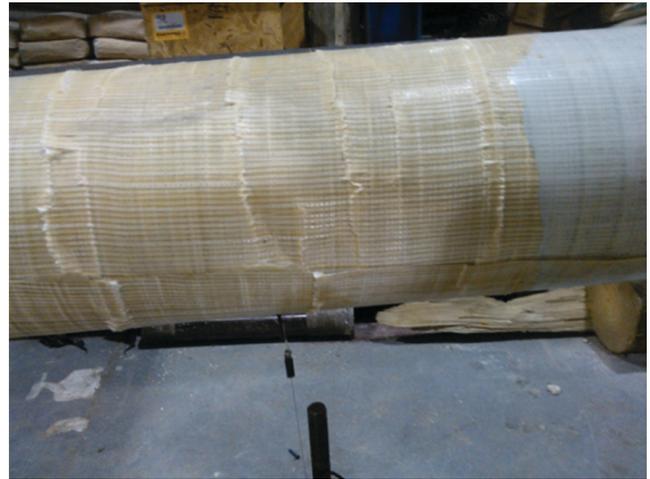
(a)

(b)

FIGURE 5 Failure of Specimen 1 (damage 1-in. deep filled with resin): (a) near fixed end and (b) at repair location.

Specimen 1, with damage 1-in. deep filled by resin, showed the highest ultimate load capacity of the five specimens tested as part of this study. The specimen failed at an approximately 177-kip axial load with rapid cracking. Major damage was observed at two locations after the failure of the specimen: near the fixed end, where the pile had a big longitudinal crack that split the pile into two halves, and at the repair location, where there was ripping and delamination of the GFRP jacket (Figure 5). The damage in both cases occurred at failure and was not progressive.

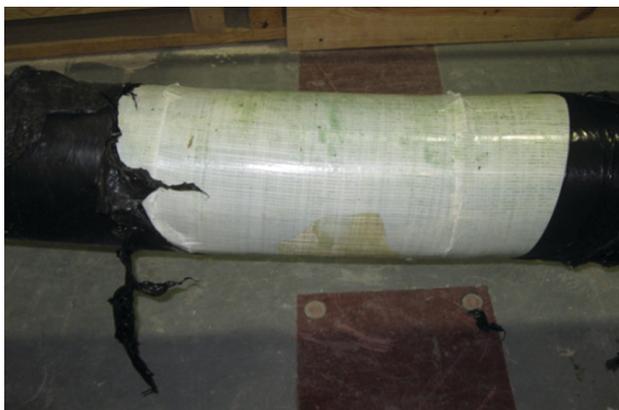
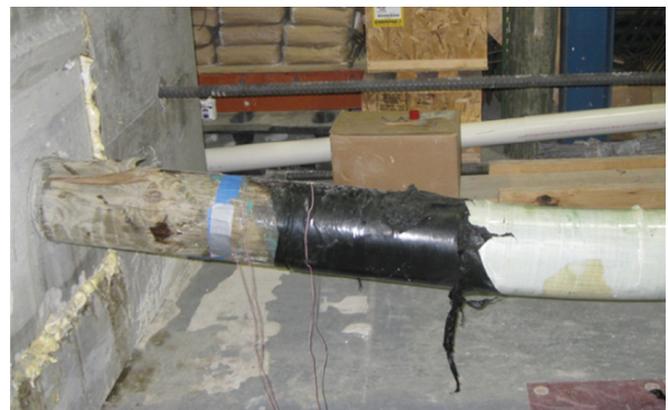
FIGURE 6 Failure of Specimen 2 (damage 1.5-in. deep filled with resin).

tested in this study. This specimen failed mainly as the result of large gradual deflection at the repair location (Figure 6). The FRP jacket was damaged at the two ends of the 14-in.-long damaged region. The test continued even after the large downward deflection of the repaired region, which resulted in the cracking of the fixed end of the pile.

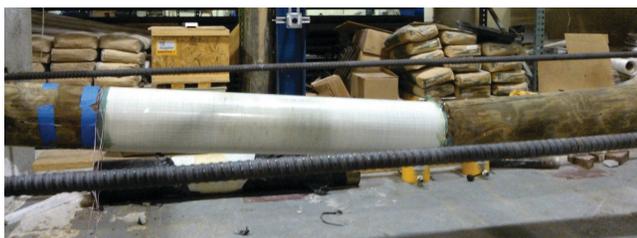
FIGURE 7 Failure of Specimen 3 (damage 2-in. deep filled with grout).

Specimen 3, with damage 2-in. deep filled with grout, took nearly a 120-kip maximum axial load before failure. The specimen showed no sign of damage in the repair region. The damage was observed at one end of the FRP wrap, which was 12 in. away from the boundary of the damaged region (Figure 7). Inspection of the failed specimen indicated bending-type failure, which resulted in crumpling top fibers and splintering bottom fibers. No damage to the FRP wrap was observed during this test.

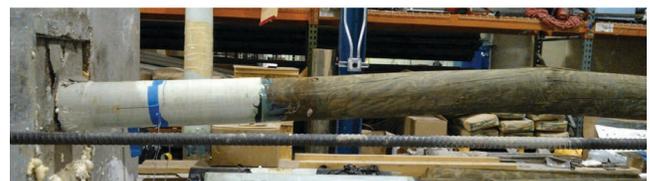
FIGURE 8 Failure of Specimen 4 (damage 2-in. deep filled with grout).

Specimen 4 also had damage 2-in. deep filled with grout similar to that used for Specimen 3. However, the location of the damaged region was different. In Specimen 4, the damaged region was placed at the most critical location (fixed end) in an attempt to fail the specimen in the damaged region. The failure of this specimen, however, appeared away from the damaged region during the test (Figure 8). The specimen took an approximately 170-kip maximum axial load before failure. This specimen bent upward, unlike the other test specimens, which bent downward. This difference resulted from the failure onset, through the failure of weak grains at the bottom of the section, which reversed the bending direction of the test specimen.

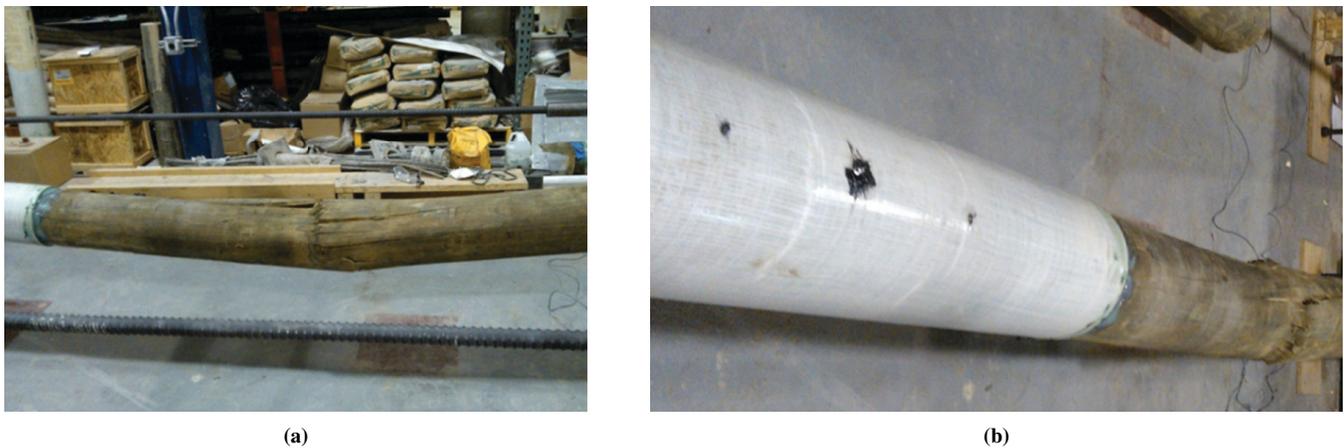
FIGURE 9 Failure of Specimen 5 (damage 2-in. deep filled with resin and gravel): (a) damage away from repaired section and (b) insignificant damage to FRP jacket.

Specimen 5, with damage 2-in. deep filled with resin gravel, failed at an approximately 115-kip axial load. The failure took place away from the repaired section (Figure 9). Insignificant damage was observed in the FRP jacket on the repaired section.
