## PileMedic Repair of Termite Damaged Utility Poles

**Santee Cooper - Wando, SC**

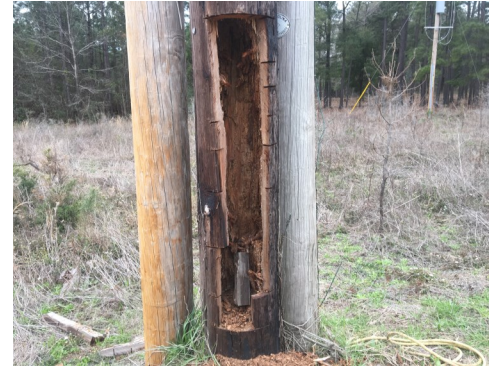
Santee Cooper provides electricity to a BP chemical plant via a 230kV feeder line in a remote area on the Cooper River. The plant operates continuously year around and power shutdowns are very expensive for the plant. Termite damage to 4 structures was extensive, leading to section loss up to 75%. The required repairs needed to be performed with energized power lines and limited disruption to the fragile poles.
